date: DECEMBER 1975."

AIRFIELD PAVEMENT CONDITION SURVEY, USNAS MIRAMAR, CALIFORNIA

Technical Memorandum M-75-53-2

R. B. Brownie

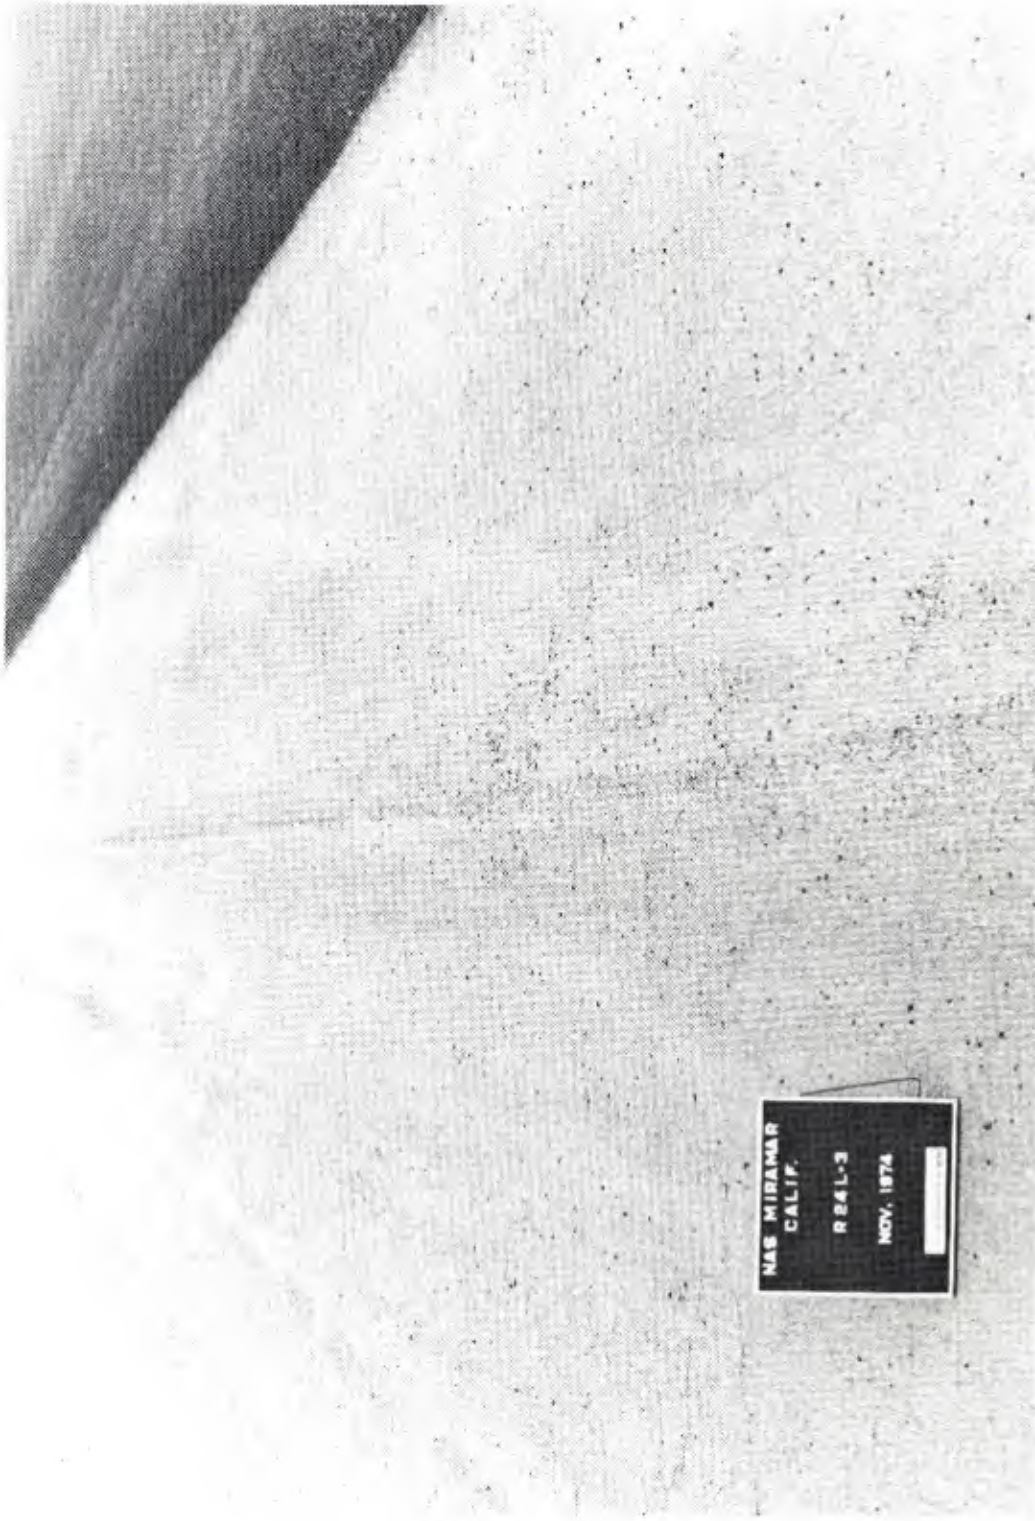
Figure 3. Loose aggregate blown onto runway shoulder from rubber-asphalt seal, Discrete Area R24L-3.

The rubber-asphalt seal coat placed in October, 1974 has covered any cracks. The seal coat is losing some aggregate, necessitating periodic sweeping (See Figure 3). The application of chips during the construction of the seal coat was apparently uneven as evidenced by a wash-board effect in some lanes (see Figure 4).

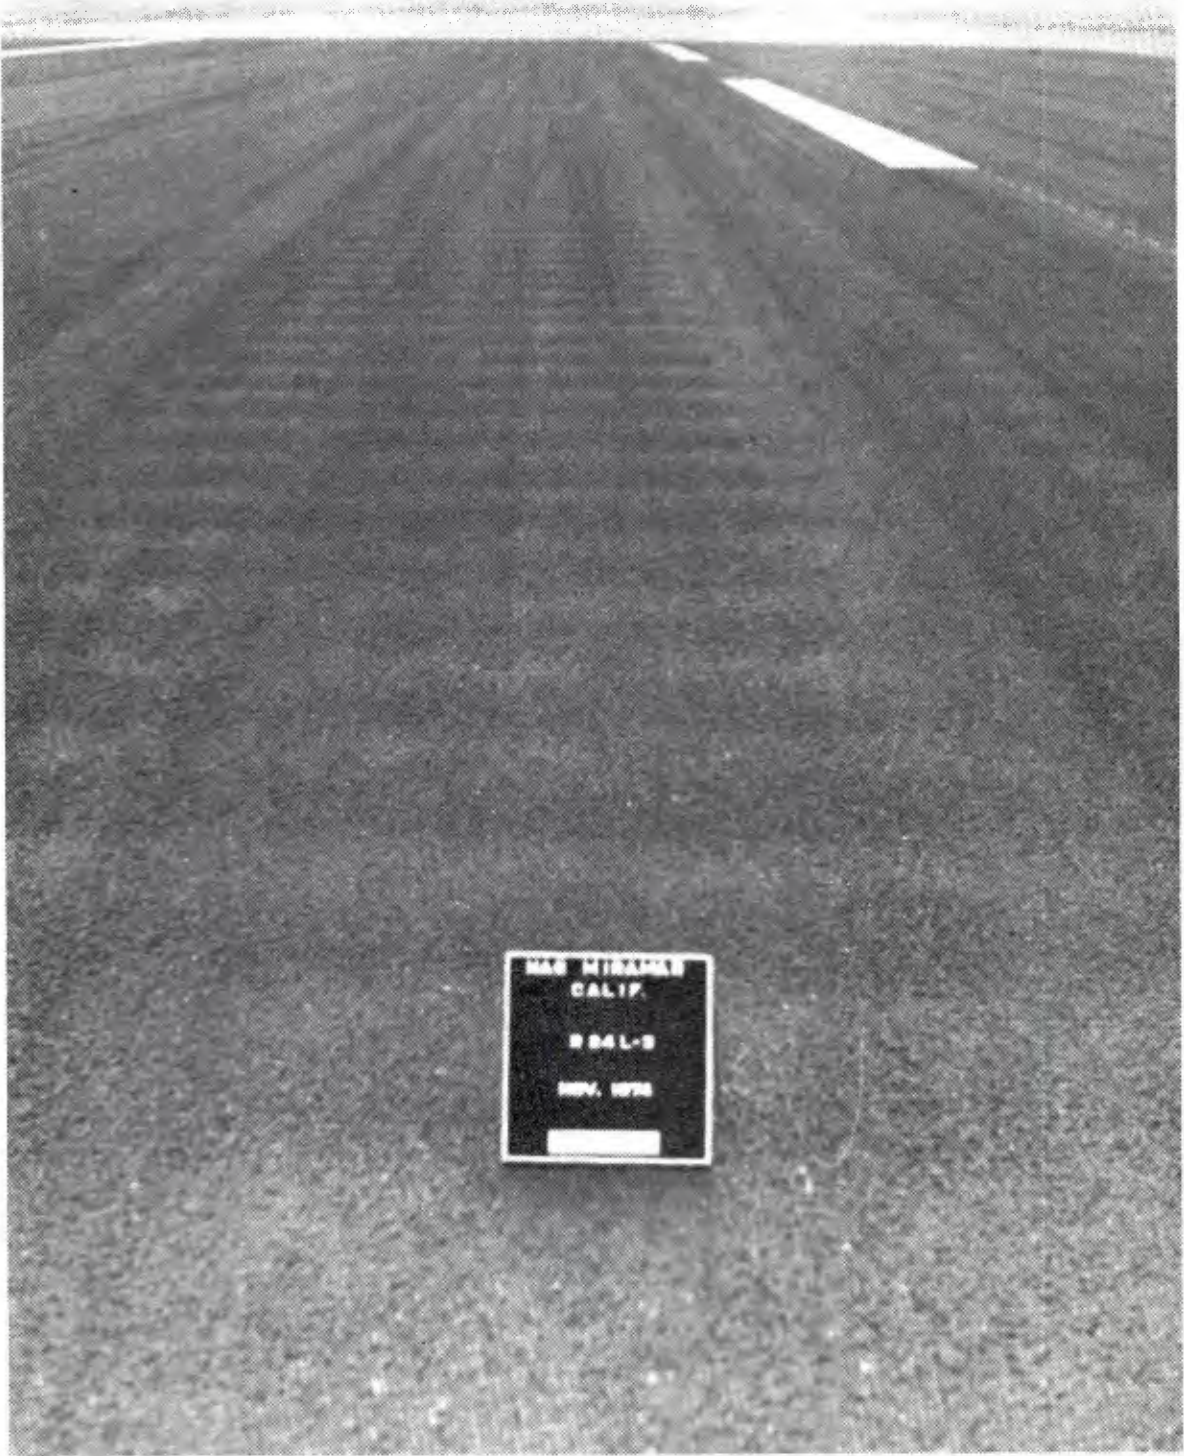
Figure 4. Washboard effect caused by poor chip distribution, Discrete Area R24L-3.

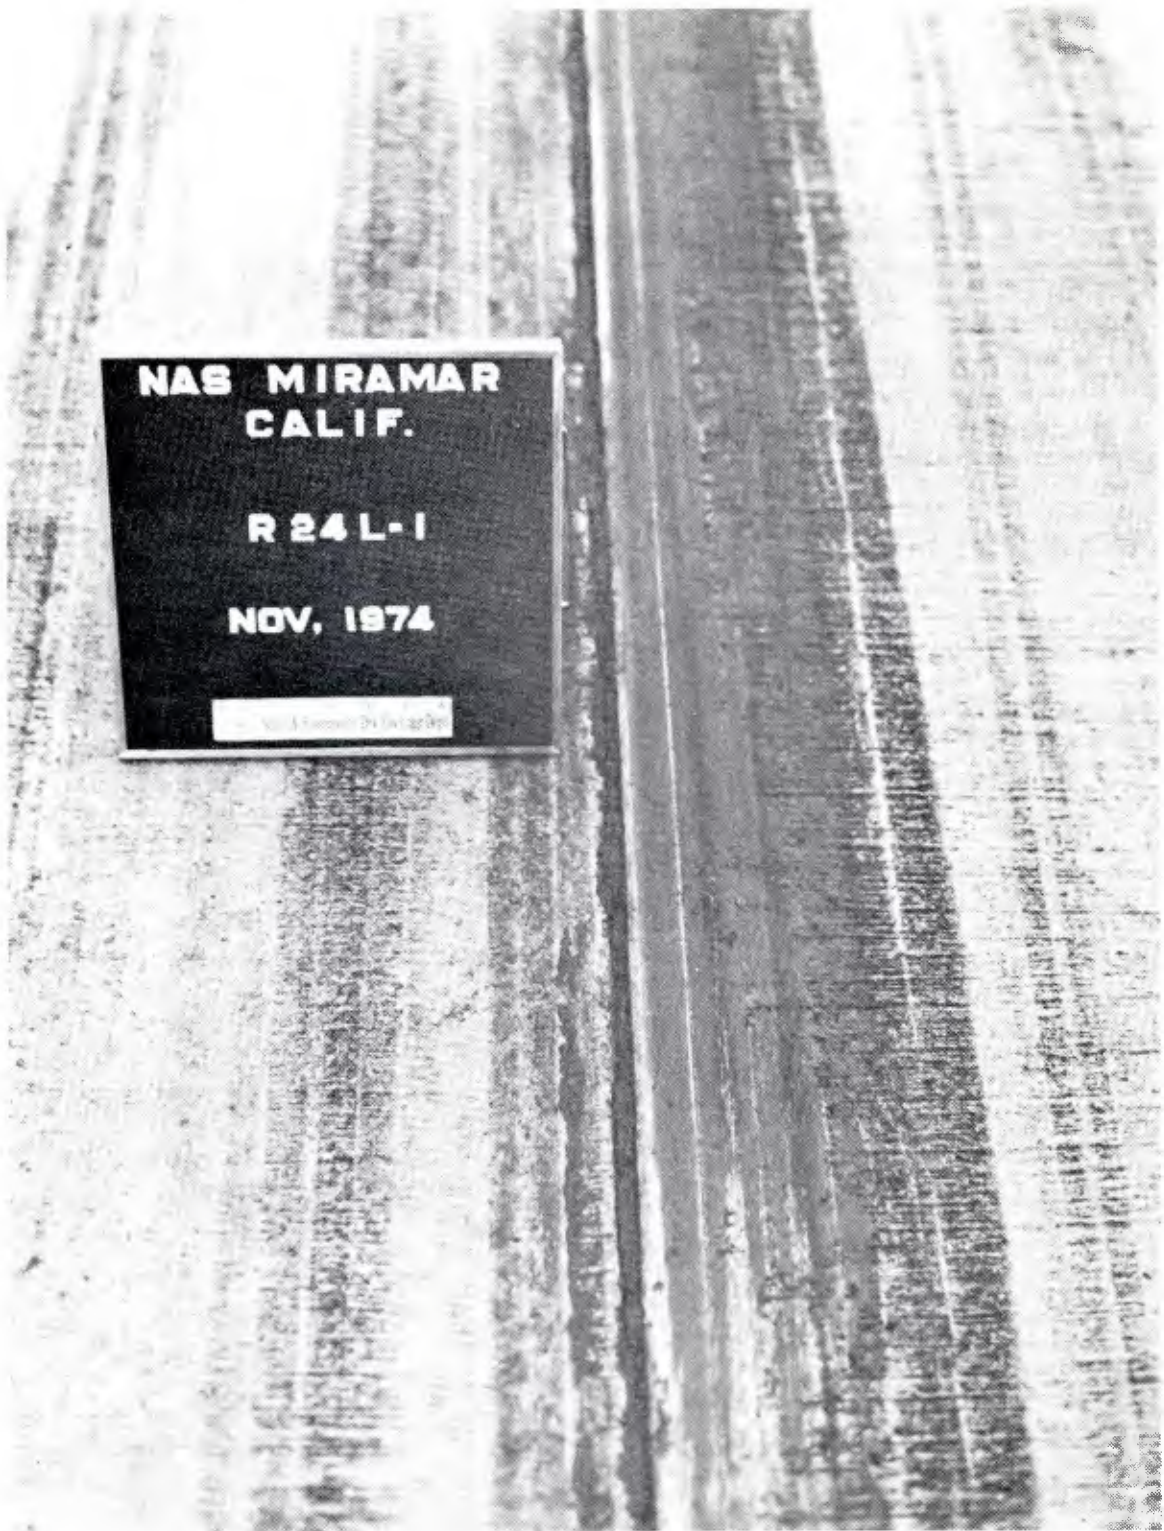
Figure 5. Shriveled and hardened joint seal, Discrete Area R24L-1.

| Defect Type | No. of Sample Slabs w/Defect | Total Slabs w/Defect: c x a/b | Defect Density (per slab) d/a | Defect Severity Weight | Weighted Defect Density e x f |
|--|---|---|--|---|--|
| Joint seal was very hard and occasionally was burned by jet blast (see Figure 5). Many spalls had been repaired during 1974 and most repairs were effective (see Figure 6). The remaining spalls were generally small, 1" to 4" in length and less than 1" wide. A moderately heavy buildup of rubber was noted on the 24 end of the runway. | | | | | 2.100 *** |

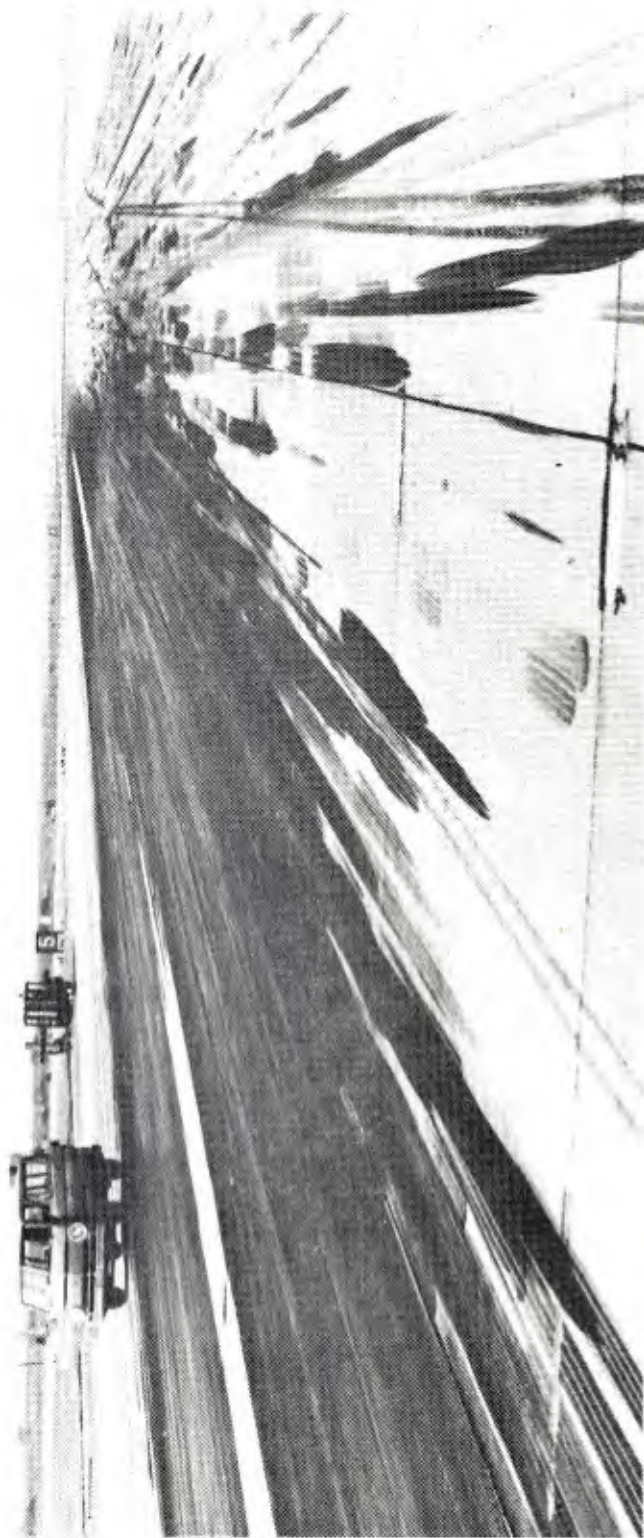
Figure 7. Heavy rubber deposits in the field carrier landing practice area, Discrete Area R24L-2.

| Defect Type | No. of Sample Slabs w/Defect | Total Slabs w/Defect: c x a/b | Defect Density (per slab) d/a | Defect Severity Weight | Weighted Defect Density e x f |
|--|---|---|--|---|--|
| <p>The joint seal was shriveled and hardened. The joint seal had lost bond in some joints. Most spalls were small, less than one inch wide. The rubber buildup in the FCLP area is very heavy (see Figure 7). It is possible to peel up strips of rubber 1/32" to 1/16" thick.</p> | | | | | 3.26C *** |

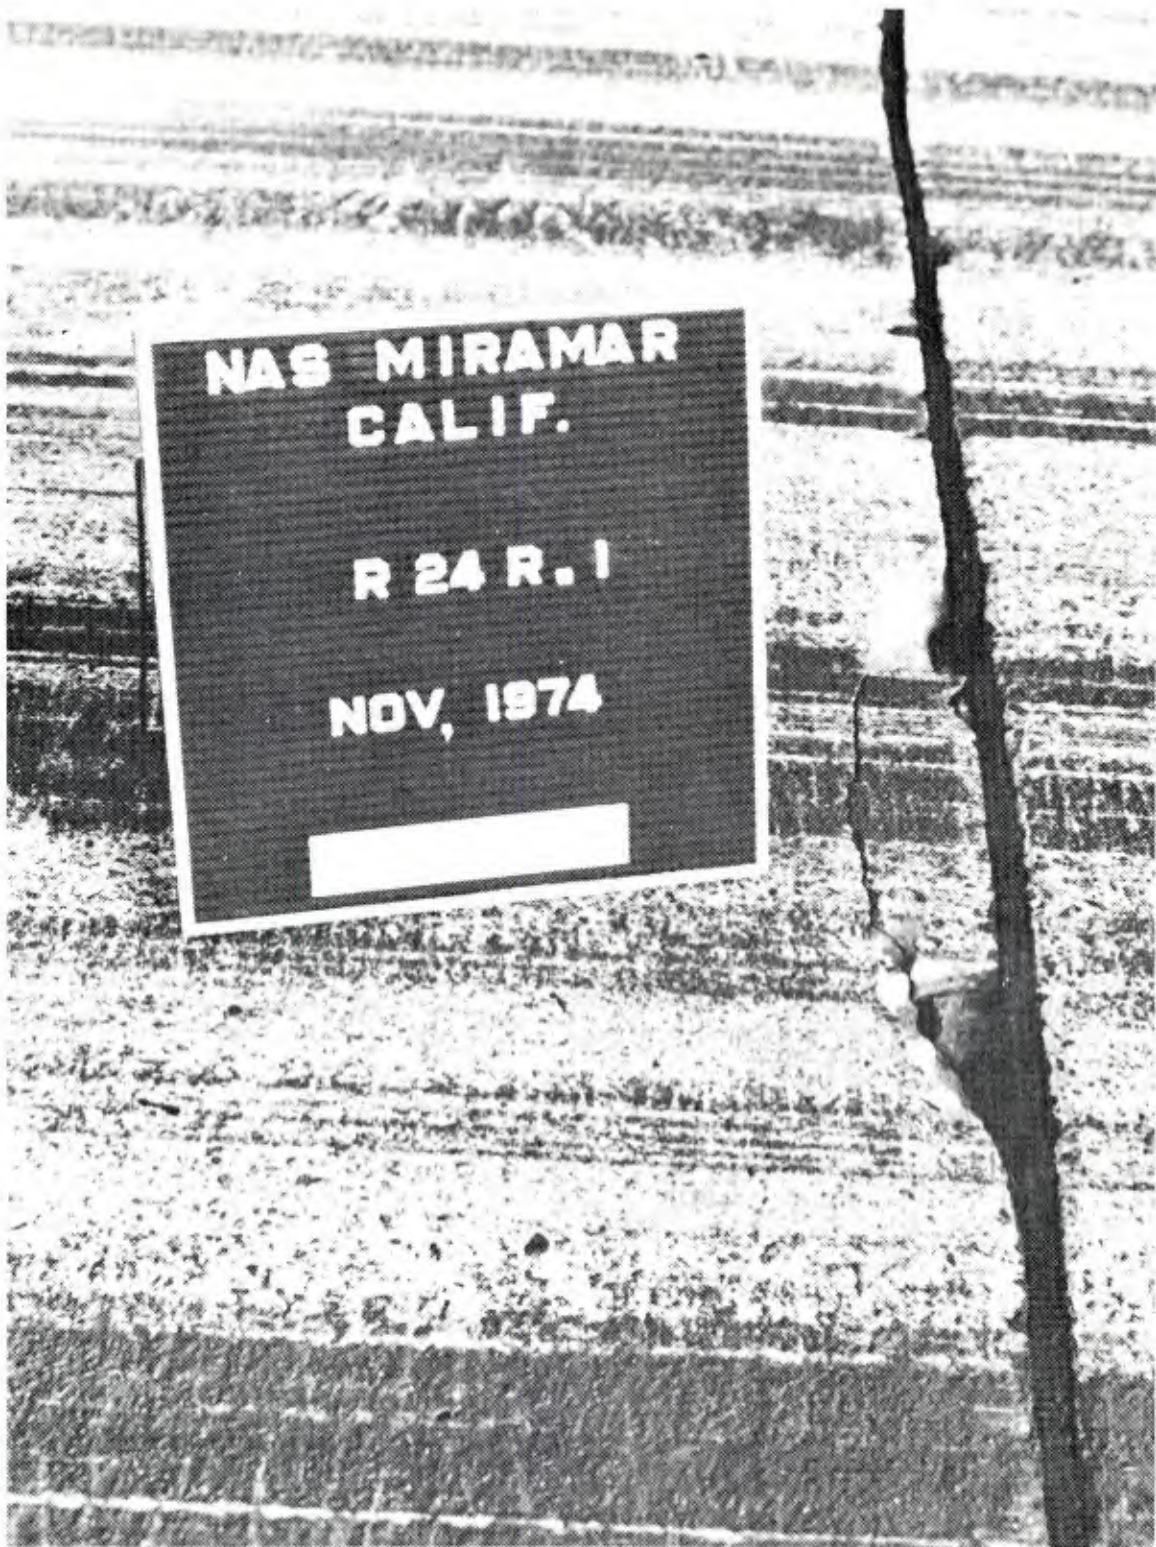
Figure 8. Typical spall, Discrete Area R24R-1.

Spalls ranged up to 4" wide and 12" long (see Figure 8). Some of the spalls noted were on old spall repairs. Spall repairs with the date 1972 on them were in generally good condition. The joint seal was hardened over the entire area and was burned and blown at the runway end (see Figure 9).

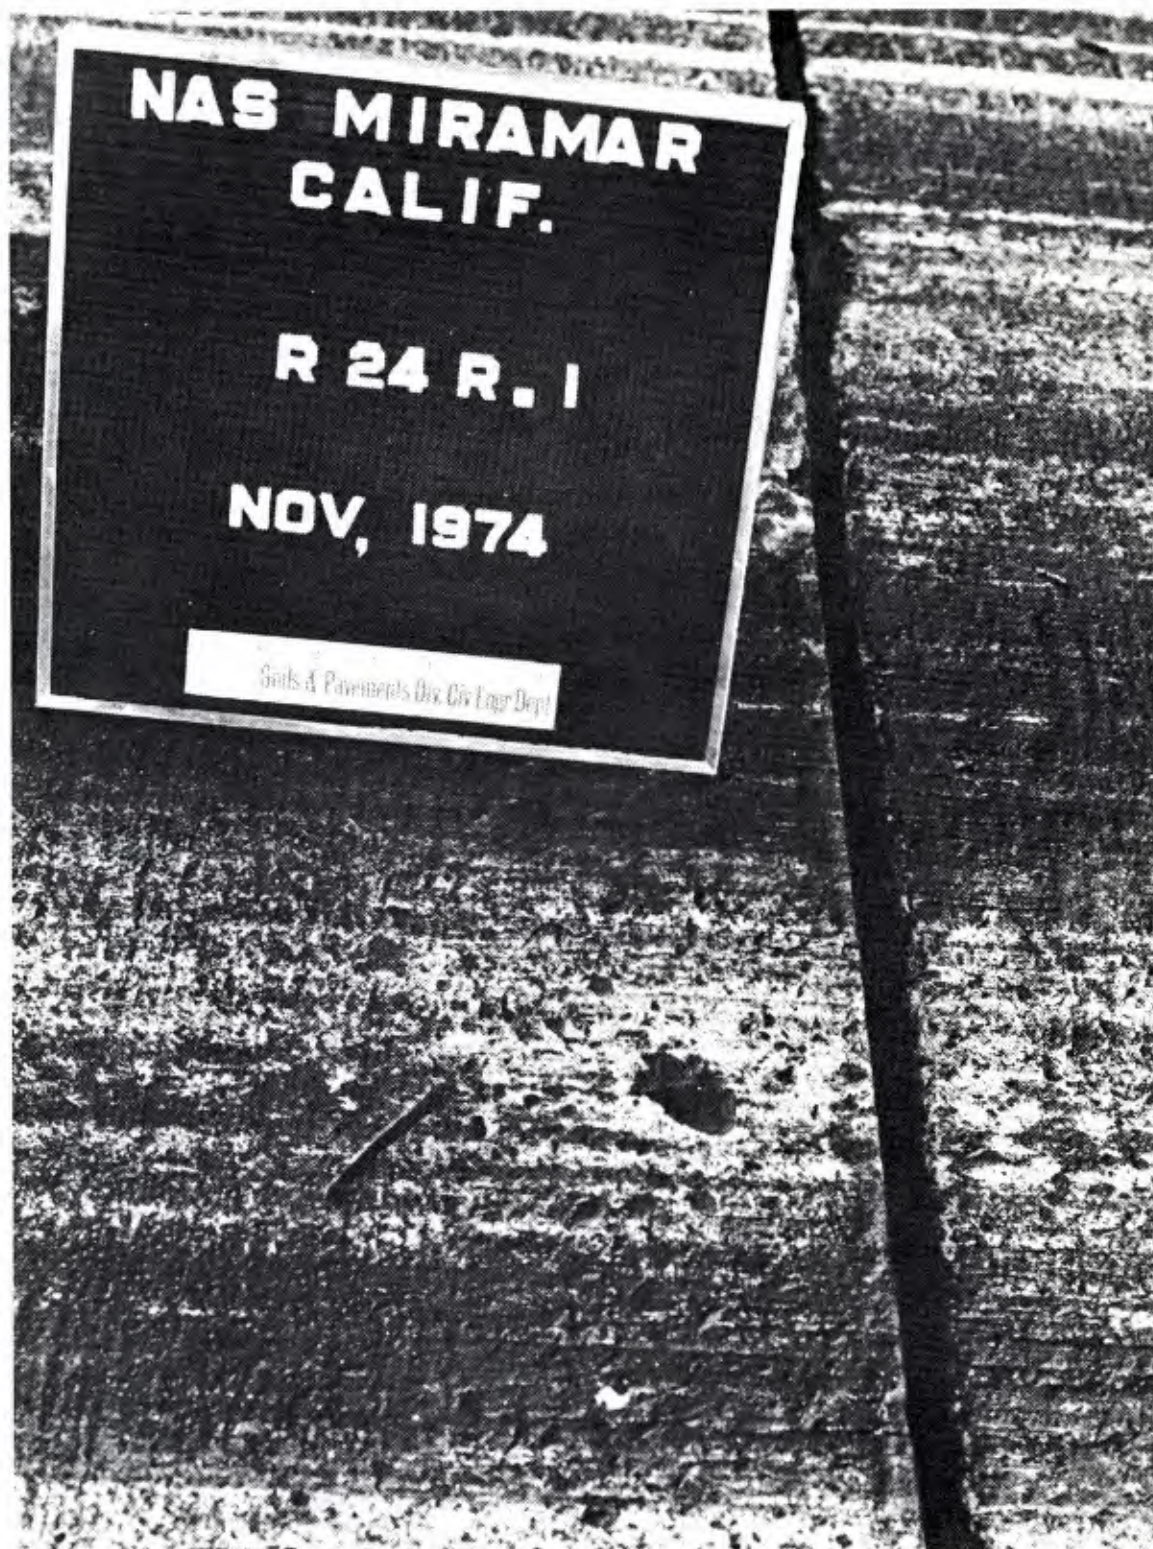
Figure 9. Burned and blown joint seal, Discrete Area R24R-1.

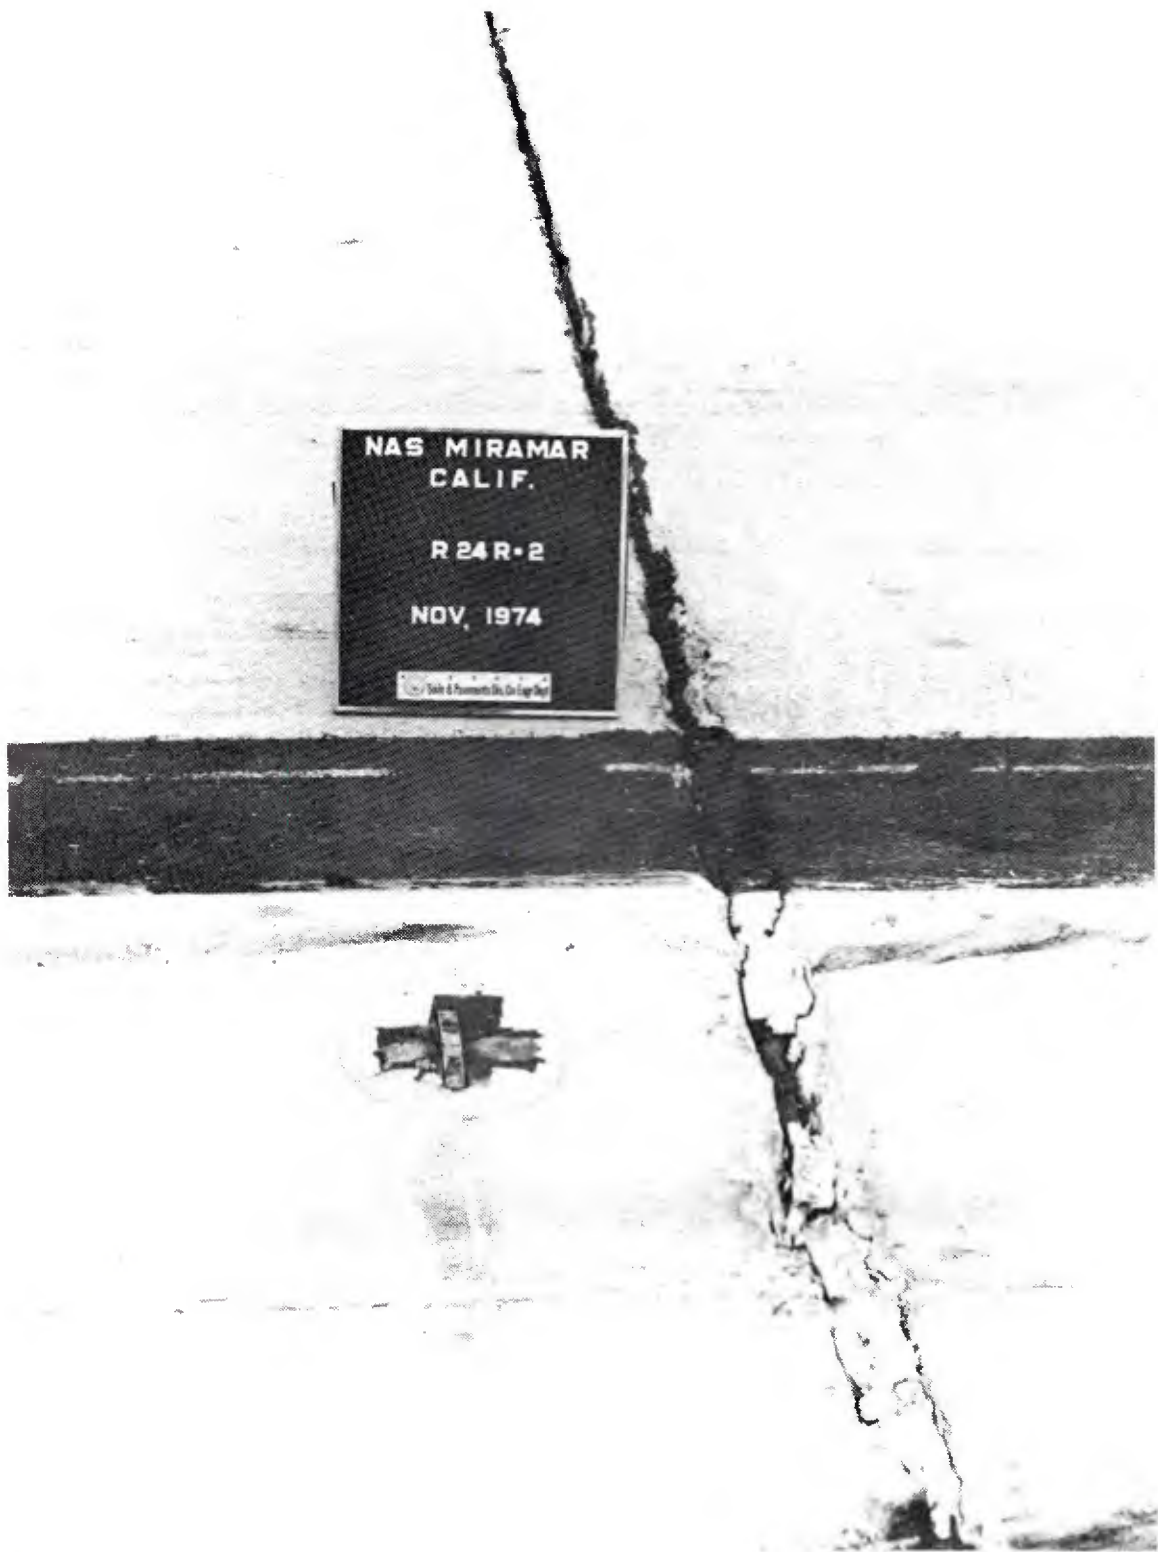
Figure 10. Hardened and shriveled joint seal, Discrete Area R24R-2.

| Defect Type | No. of Sample Slabs w/Defect | Total Slabs w/Defect: c x a/b | Defect Density (per slab) d/a | Defect Severity Weight | Weighted Defect Density e x f |
|--|---|---|--|---|--|
| <p>The joint seal was hardened and shriveled over almost the entire area (see Figure 10). Approximately 50 percent of the spalls noted were located on repaired areas.</p> | | | | | |

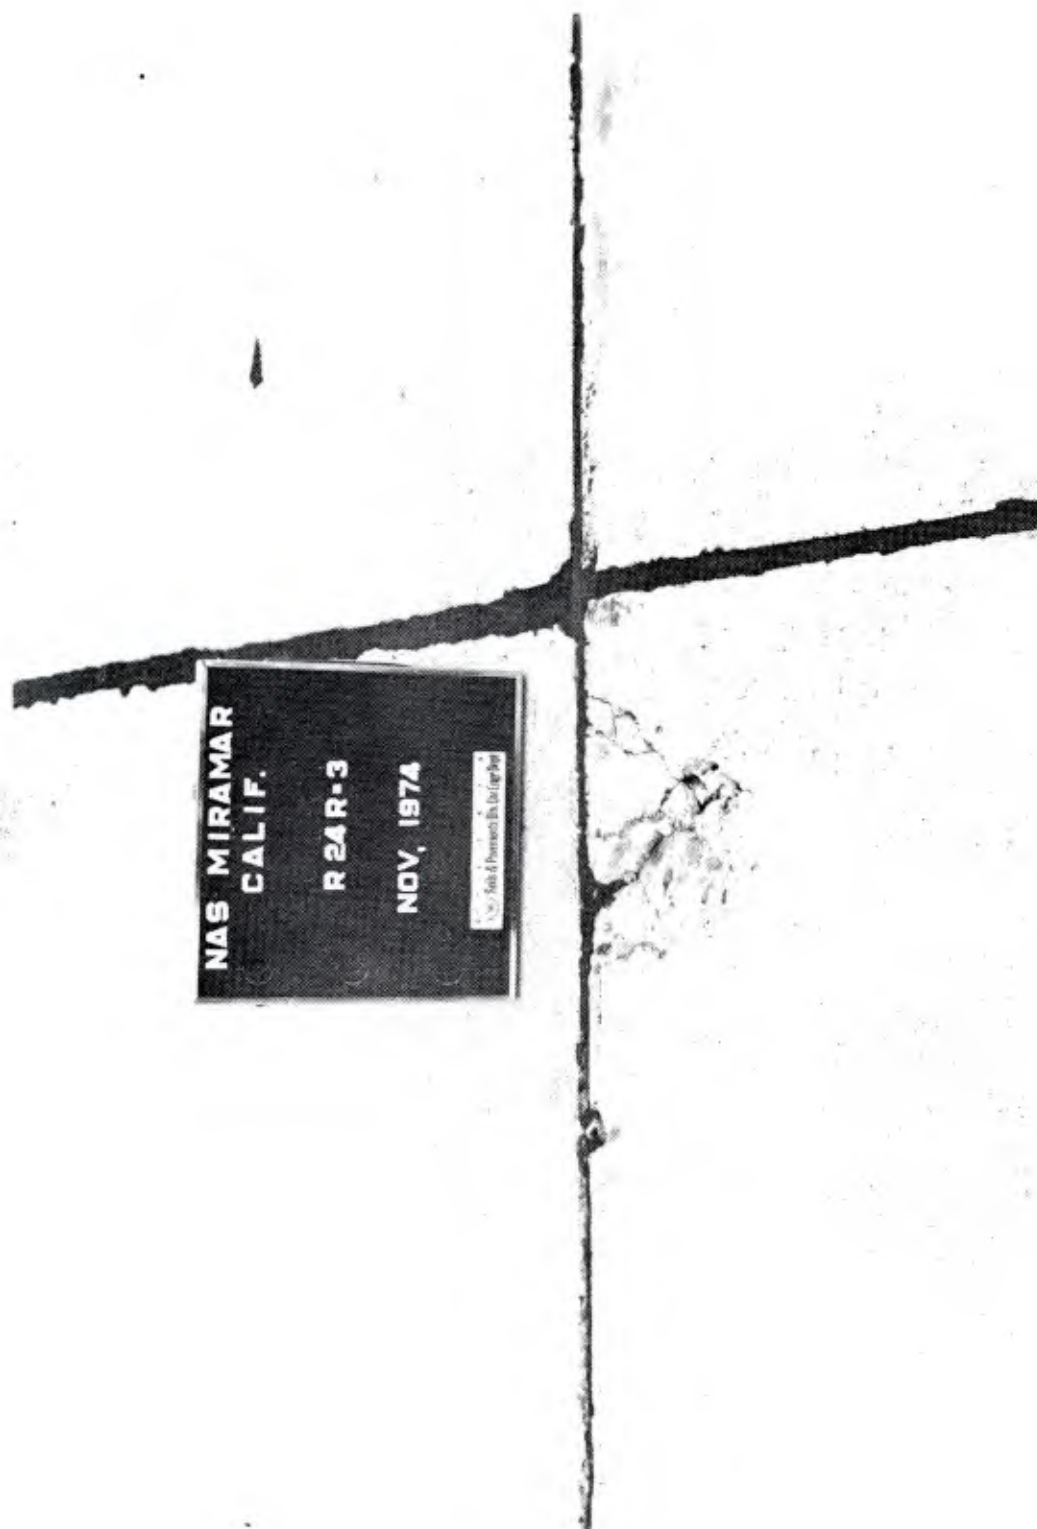
Figure 11. Typical corner spall, Discrete Area R24R-3.

The joint seal was hardened and shriveled. Joint was completely missing from a few joints. Spalls were primarily located on slab corners (see Figure 11).

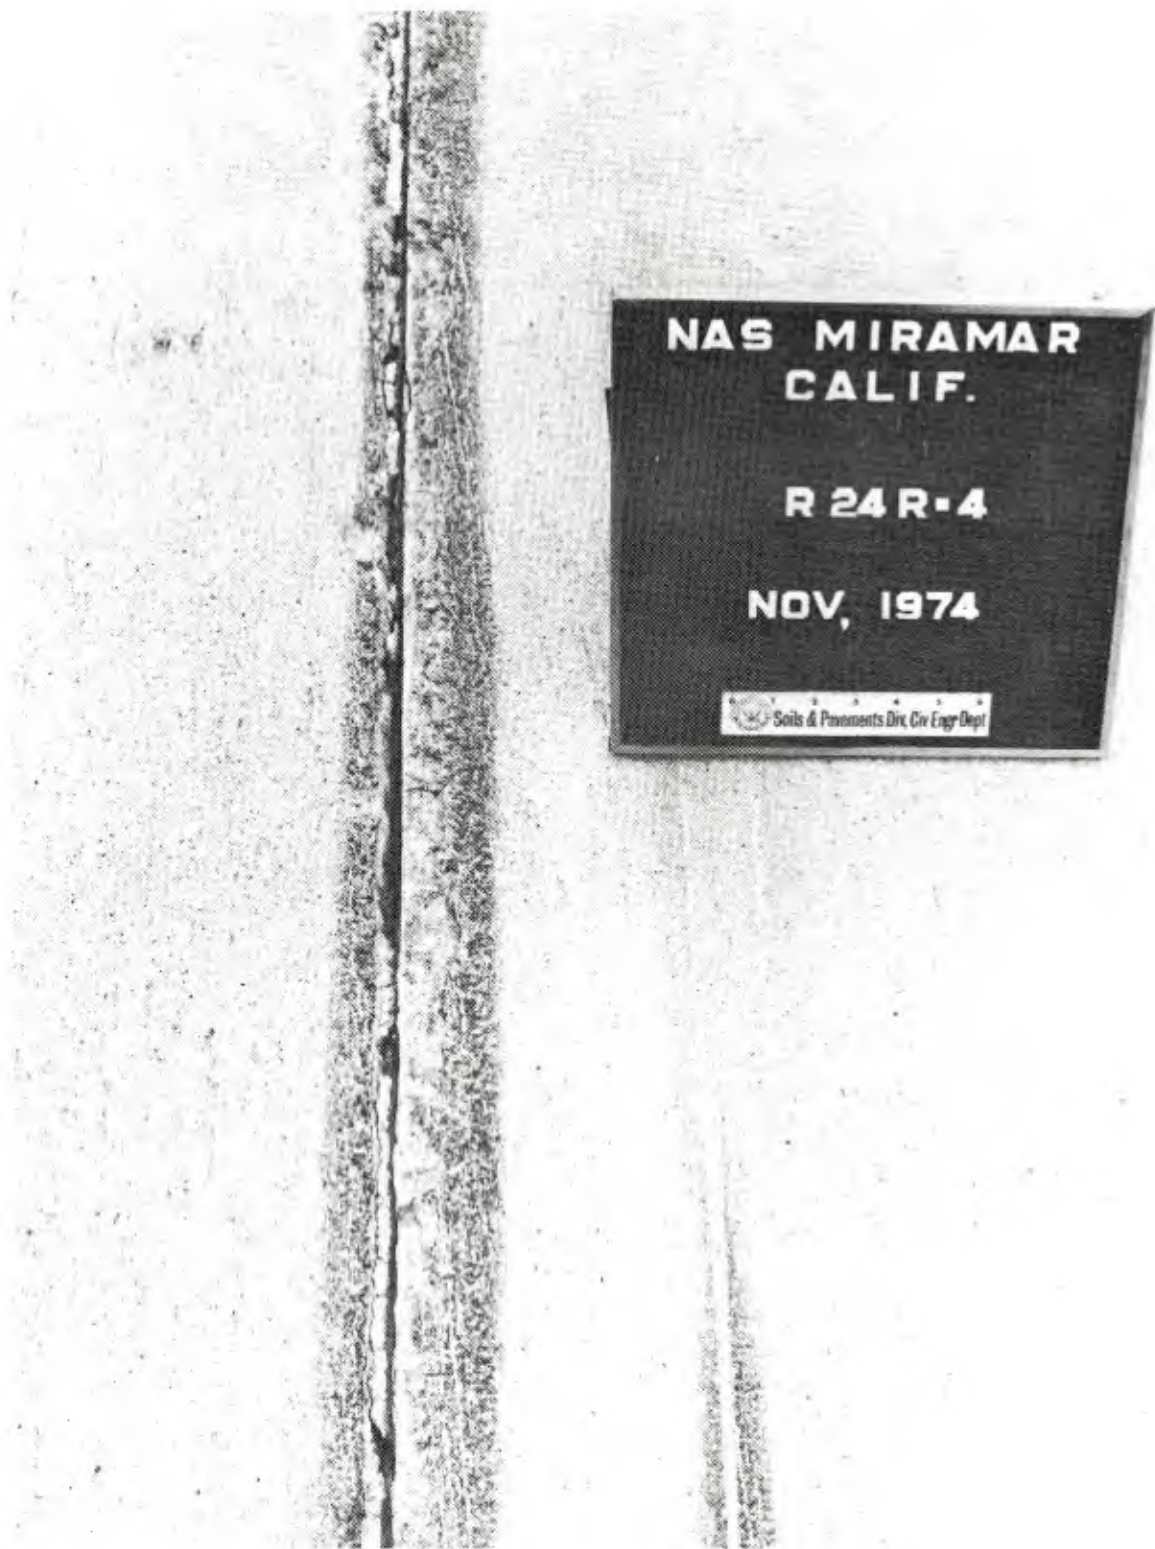
Figure 12. Hardened and shriveled joint seal, Discrete Area R24R-4.

| Defect Type | No. of Sample Slabs w/Defect | Total Slabs w/Defect: c x a/b | Defect Density (per slab) d/a | Defect Severity Weight | Weighted Defect Density e x f |
|--|---|---|--|---|--|
| <p>Joint seal was hardened and shriveled (see Figure 12). Many spalls were located on transverse expansion joints.</p> | | | | | |

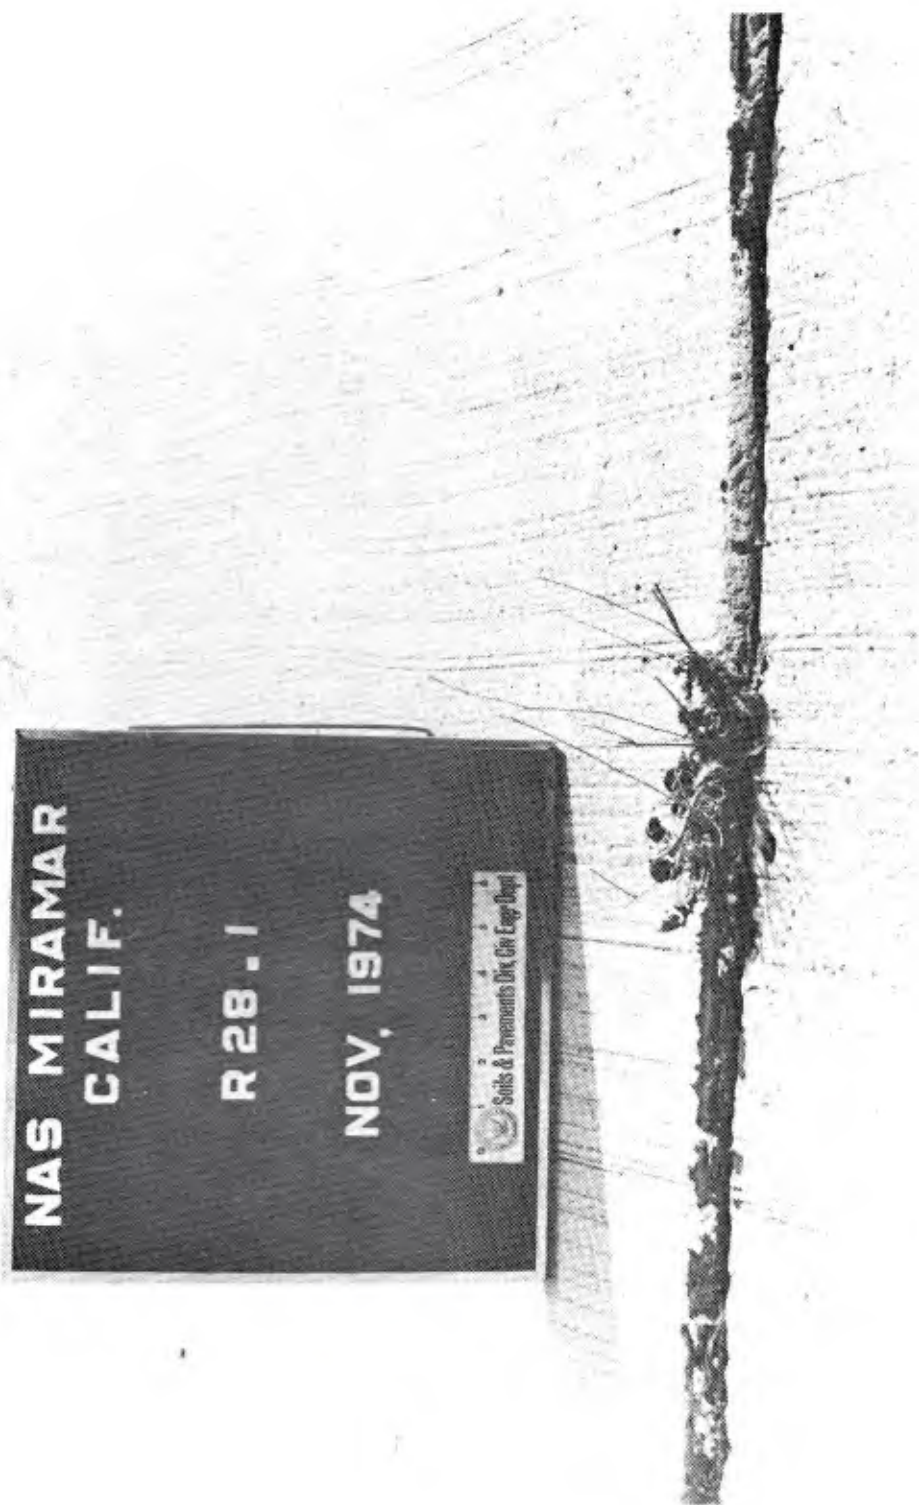
Figure 13. Vegetation growing in joint, Discrete Area R28-1.

Most spalls noted were on old epoxy repairs. Most spalls were small, less than 2" wide. The joint seal was pliable and performing adequately. Vegetation growing in the joints was the only joint seal defect noted (see Figure 13).

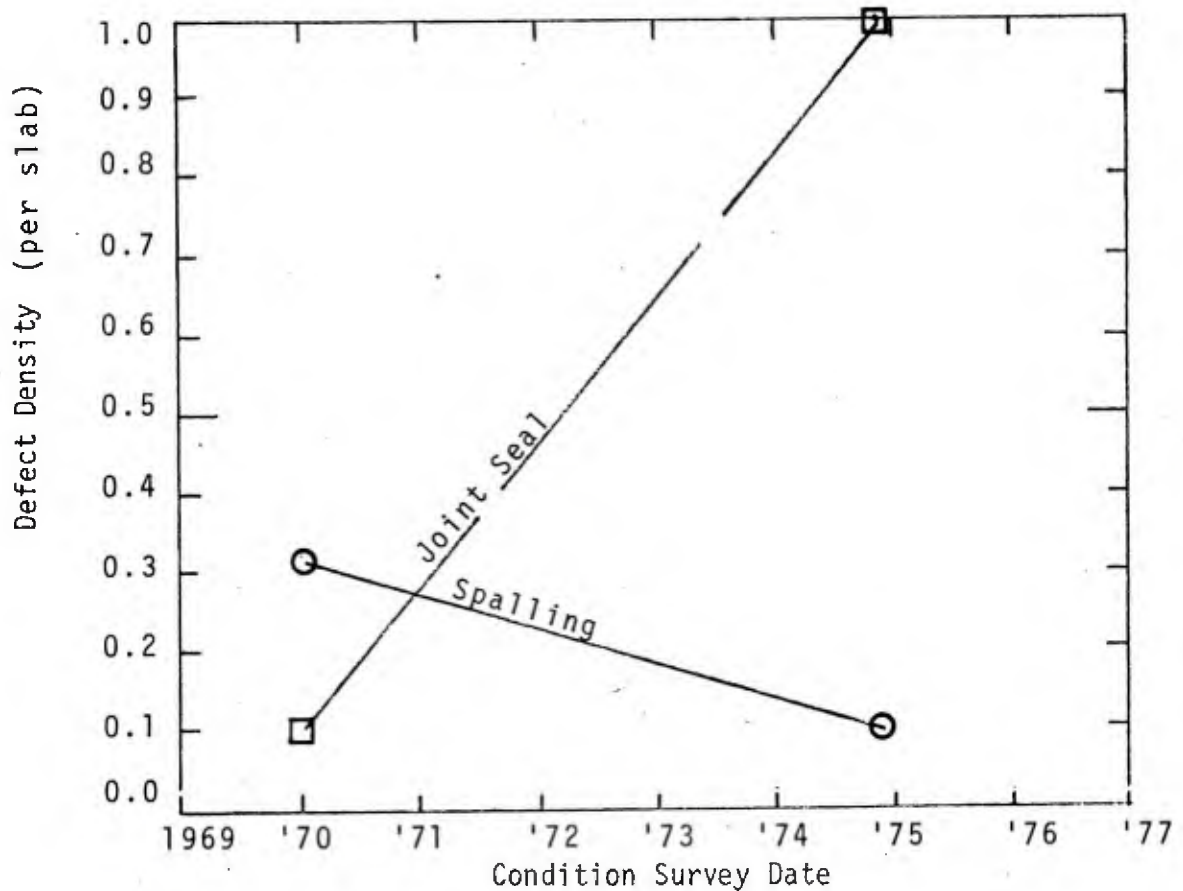
Airfield NAS Miramar Facility Runway 6L-24R
 Discrete Area R24R-1 Pavement Type PCC
Discussion

The increase in the amount of defective joint seal is attributed to effects of aging and oxidation. Most of the joint seal was placed 14 years ago.

A continuing program of spall repairs has reduced the incidence of spalling substantially.

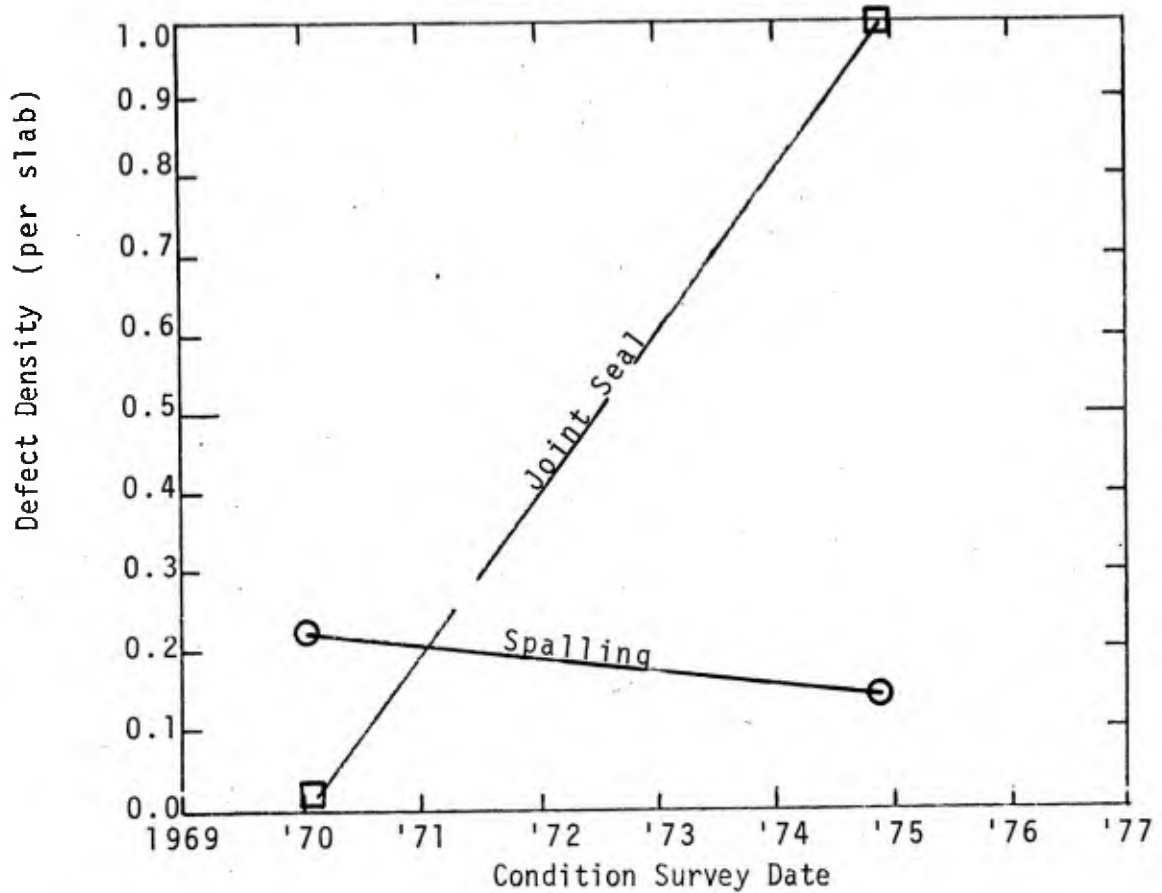
Airfield NAS Miramar Facility Runway 6L-24R
 Discrete Area R24R-2 Pavement Type PCC
Discussion

Increased joint seal defects were attributed to aging and oxidation. Spall repairs have decreased the incidence of spalling.

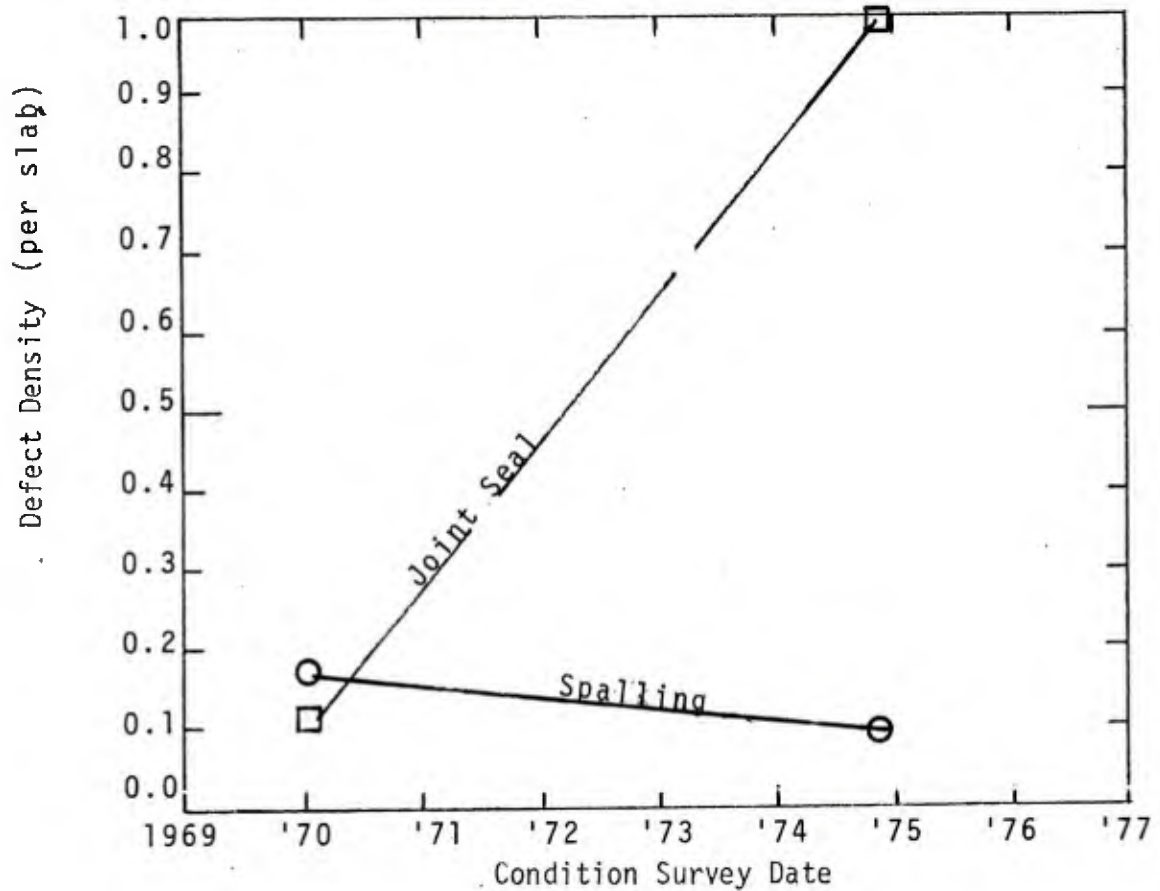
Airfield NAS Miramar Facility Runway 6R-24L
 Discrete Area R24R-3 Pavement Type OCC
Discussion

Increased joint seal defects were attributed to aging and oxidation. Spall repairs have decreased the incidence of spalling.

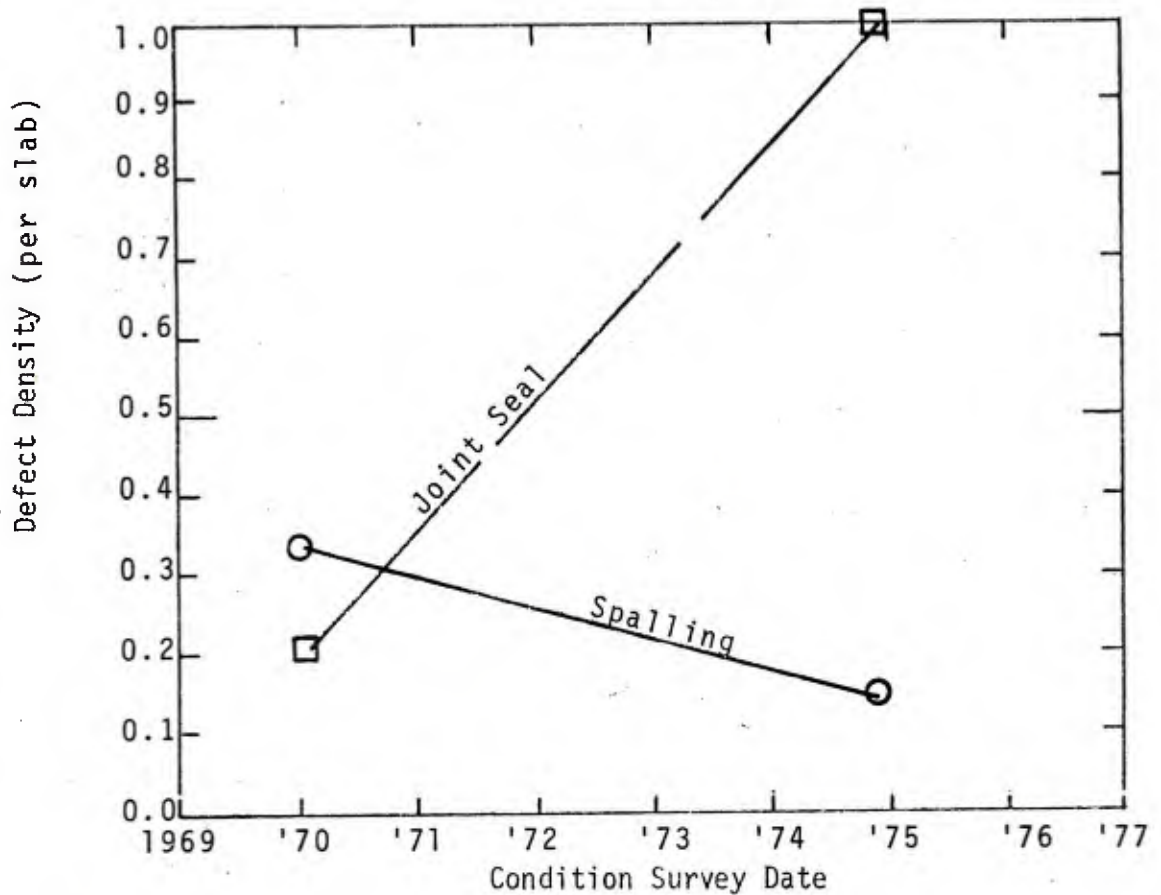
Discrete Area R24R-4 Pavement Type PCC

Increased joint seal defects were attributed to aging and oxidation. Spall repairs have decreased the incidence of spalling.

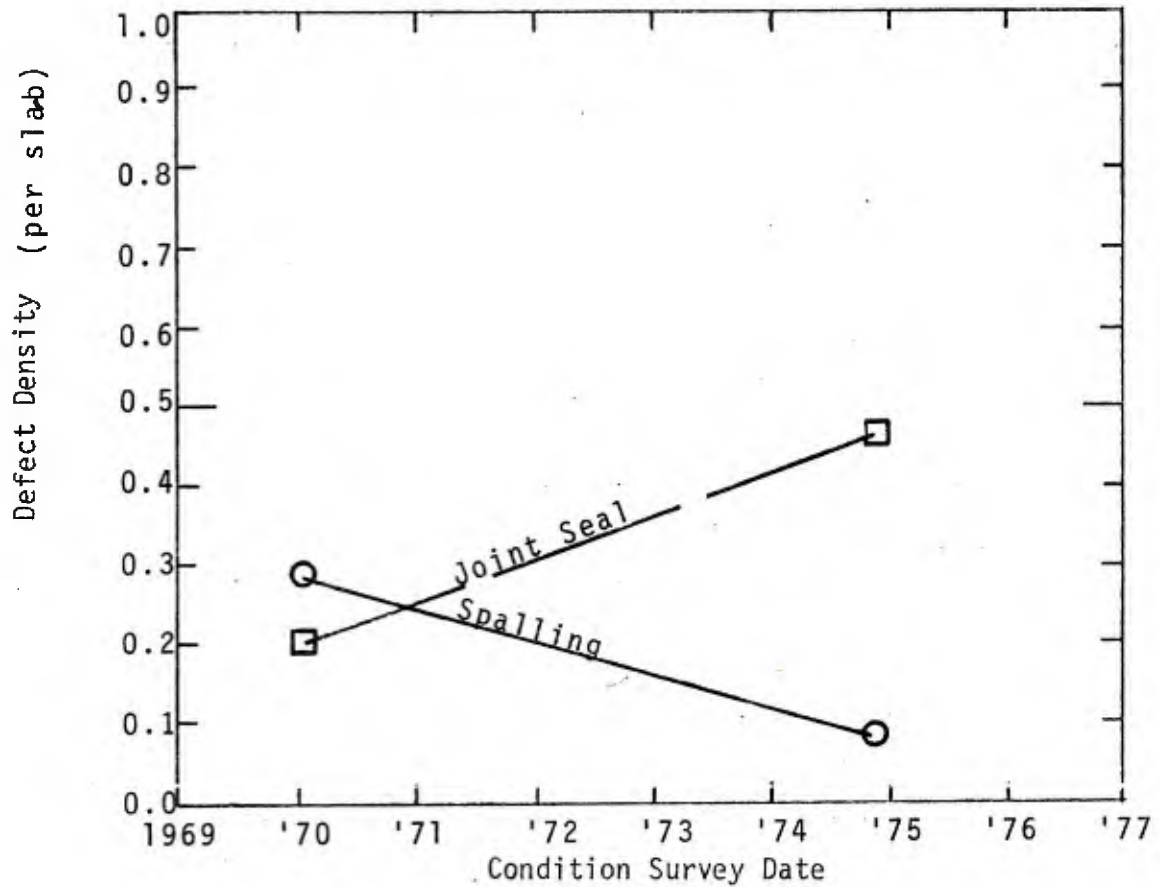
Discrete Area R 24L-1 Pavement Type PCC

Joint seal defects have increased primarily due to age and oxidation. Spall repairs completed in 1974 have decreased the incidence of spalling.
